February 1, 2010
Project No. 1406.154

Subject: Geotechnical Engineering Peer Review, 2 Irwin Way, Orinda, California

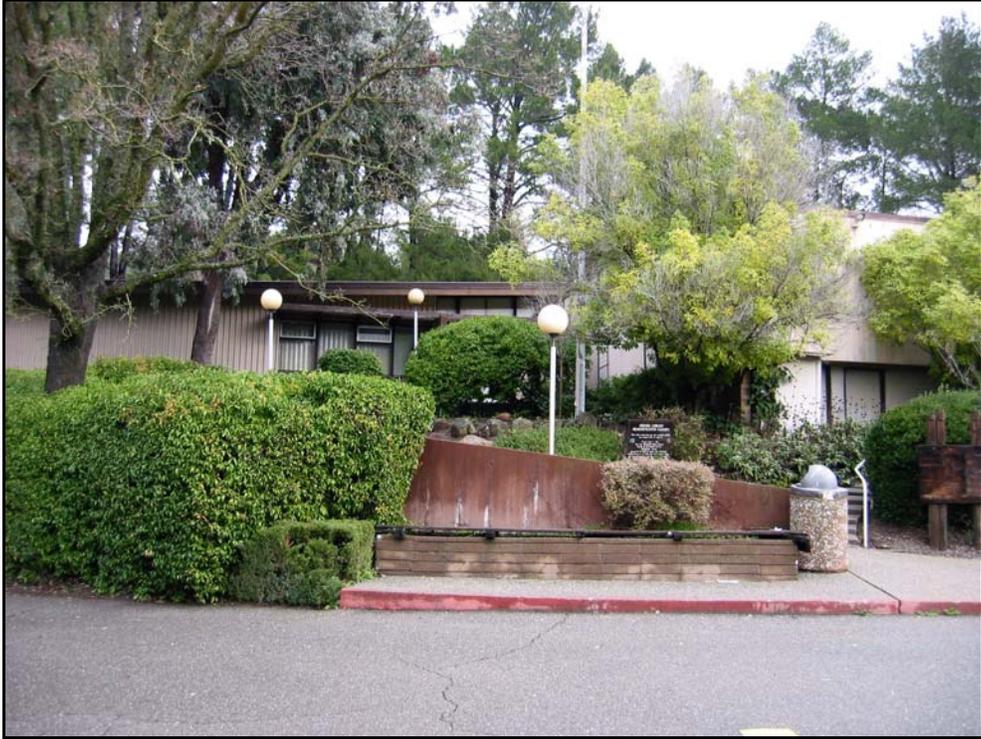
The property generally slopes to the southwest (Orinda Way) and appears to have been graded by cut and fill to create two relatively level pads. An upper pad, occupying the central & eastern portion of the property is currently occupied by the abandoned Orinda Library building (Photo Nos. 1 and 2), and a small parking area (Photo No. 3). This pad is separated from an upslope parking area for the neighboring Orinda Senior Village by a landscaped, tree-covered slope. A driveway connects the parking area to the senior village parking lot. A lower pad, situated between the library building and Orinda Way, is occupied by a larger, paved parking lot (Photo No. 4). The elevation of the lower pad/ parking lot is on the order of 10 feet higher than adjacent Orinda Way. Sloped areas not occupied by buildings or pavements were occupied by native oak and pine trees and developed landscaping. Several wood and concrete retaining walls were present across various portions of the property. In general, these walls will be removed as part of the project construction.

Photo No. 1: Abandoned Orinda Library Building (Front)

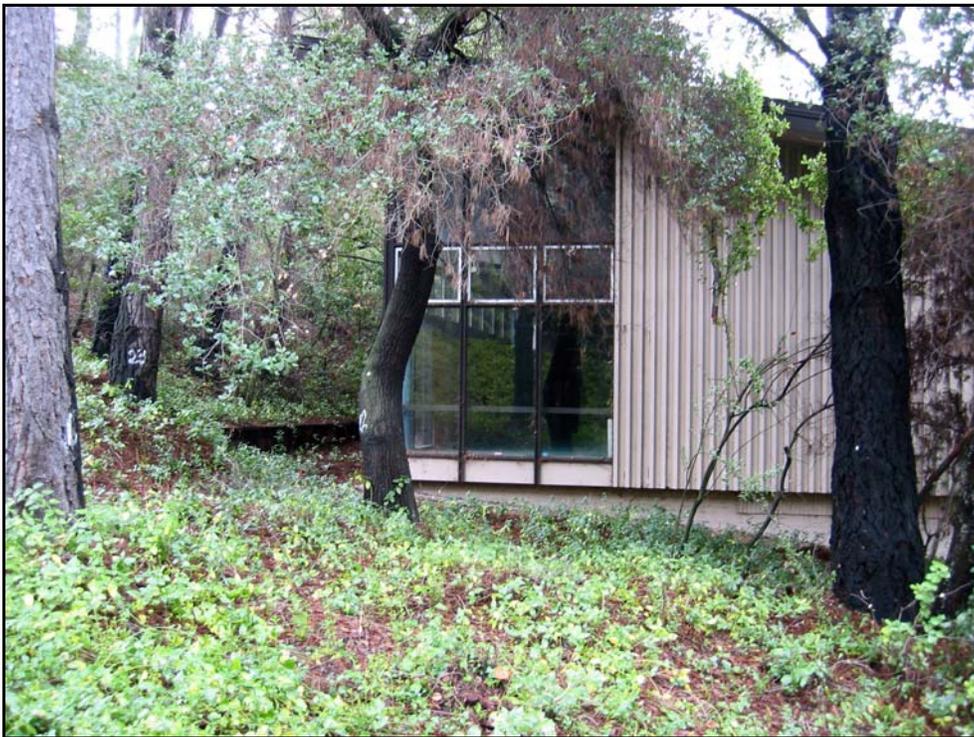
Photo No. 2: Abandoned Orinda Library Building (Side)

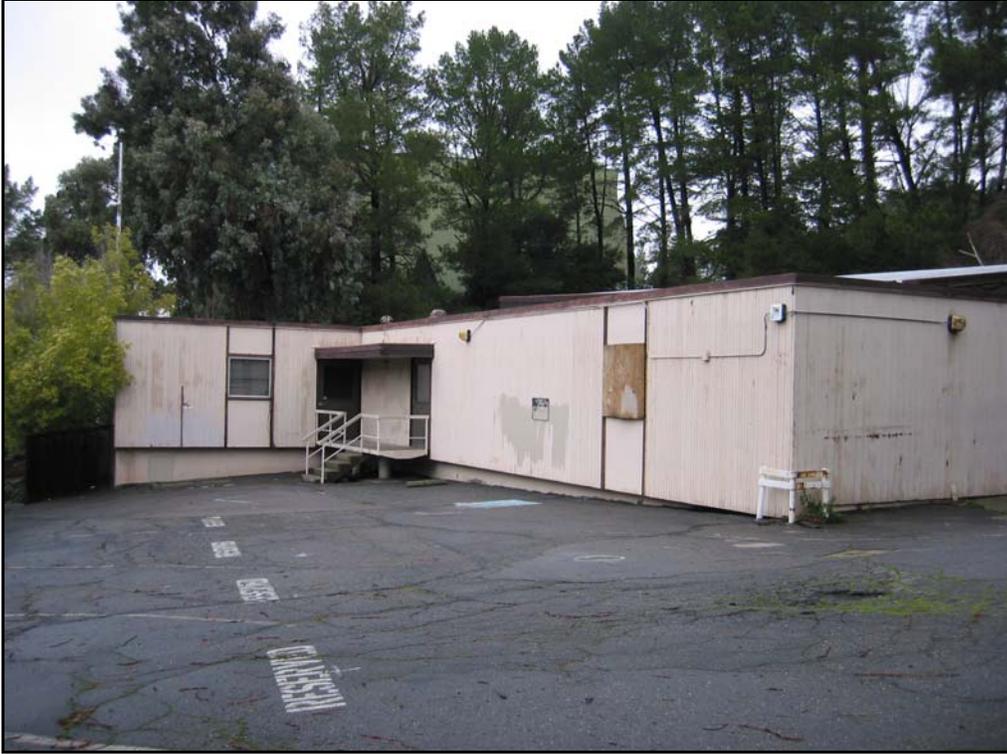
The existing pavement areas show significant cracking. Such cracking appears to be a result of a combination of pavement wear and settlement, the latter which has been attributed by the project geotechnical engineer to be the result of underlying fill settlement and deformation.

Photo No. 3: Upper Parking Area

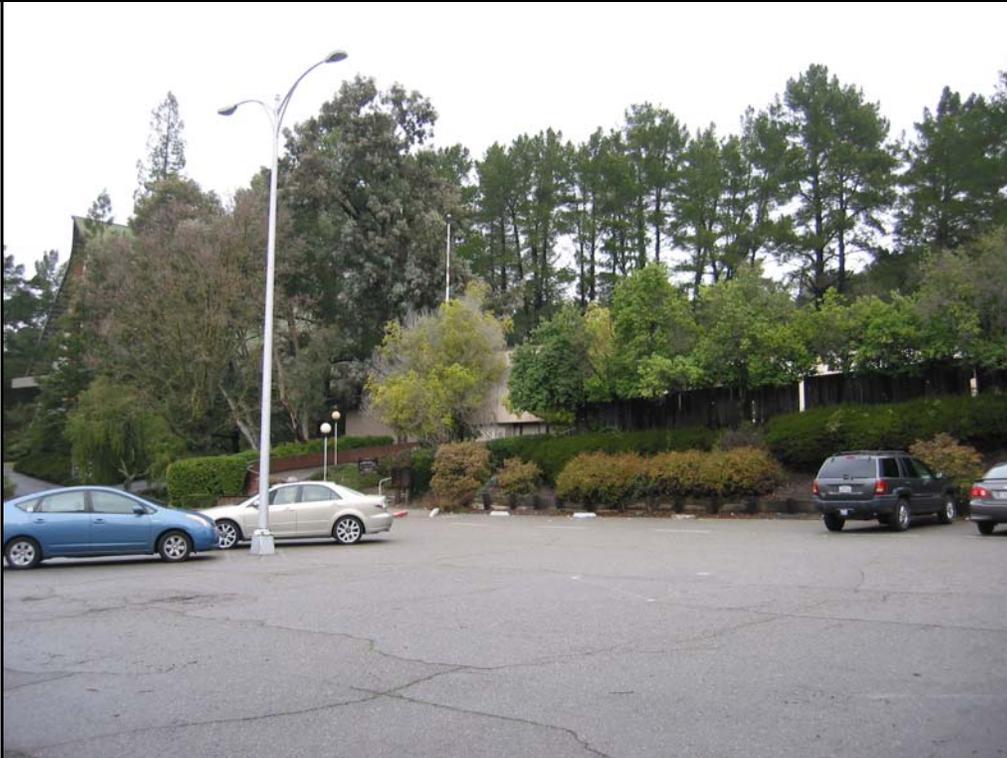
Photo No. 4: Lower Parking Lot Area
